Subject: Monitoring Well Summary Report for  
Lusher Street Groundwater Contamination Site, Elkhart, Indiana  
Contract EP-S5-06-02, Work Assignment No. 136-RICO-05AB

Monitoring Well Inventory Table  
Lusher Street Groundwater Contamination Site  
January 2017

Lusher Street Groundwater Contamination Site

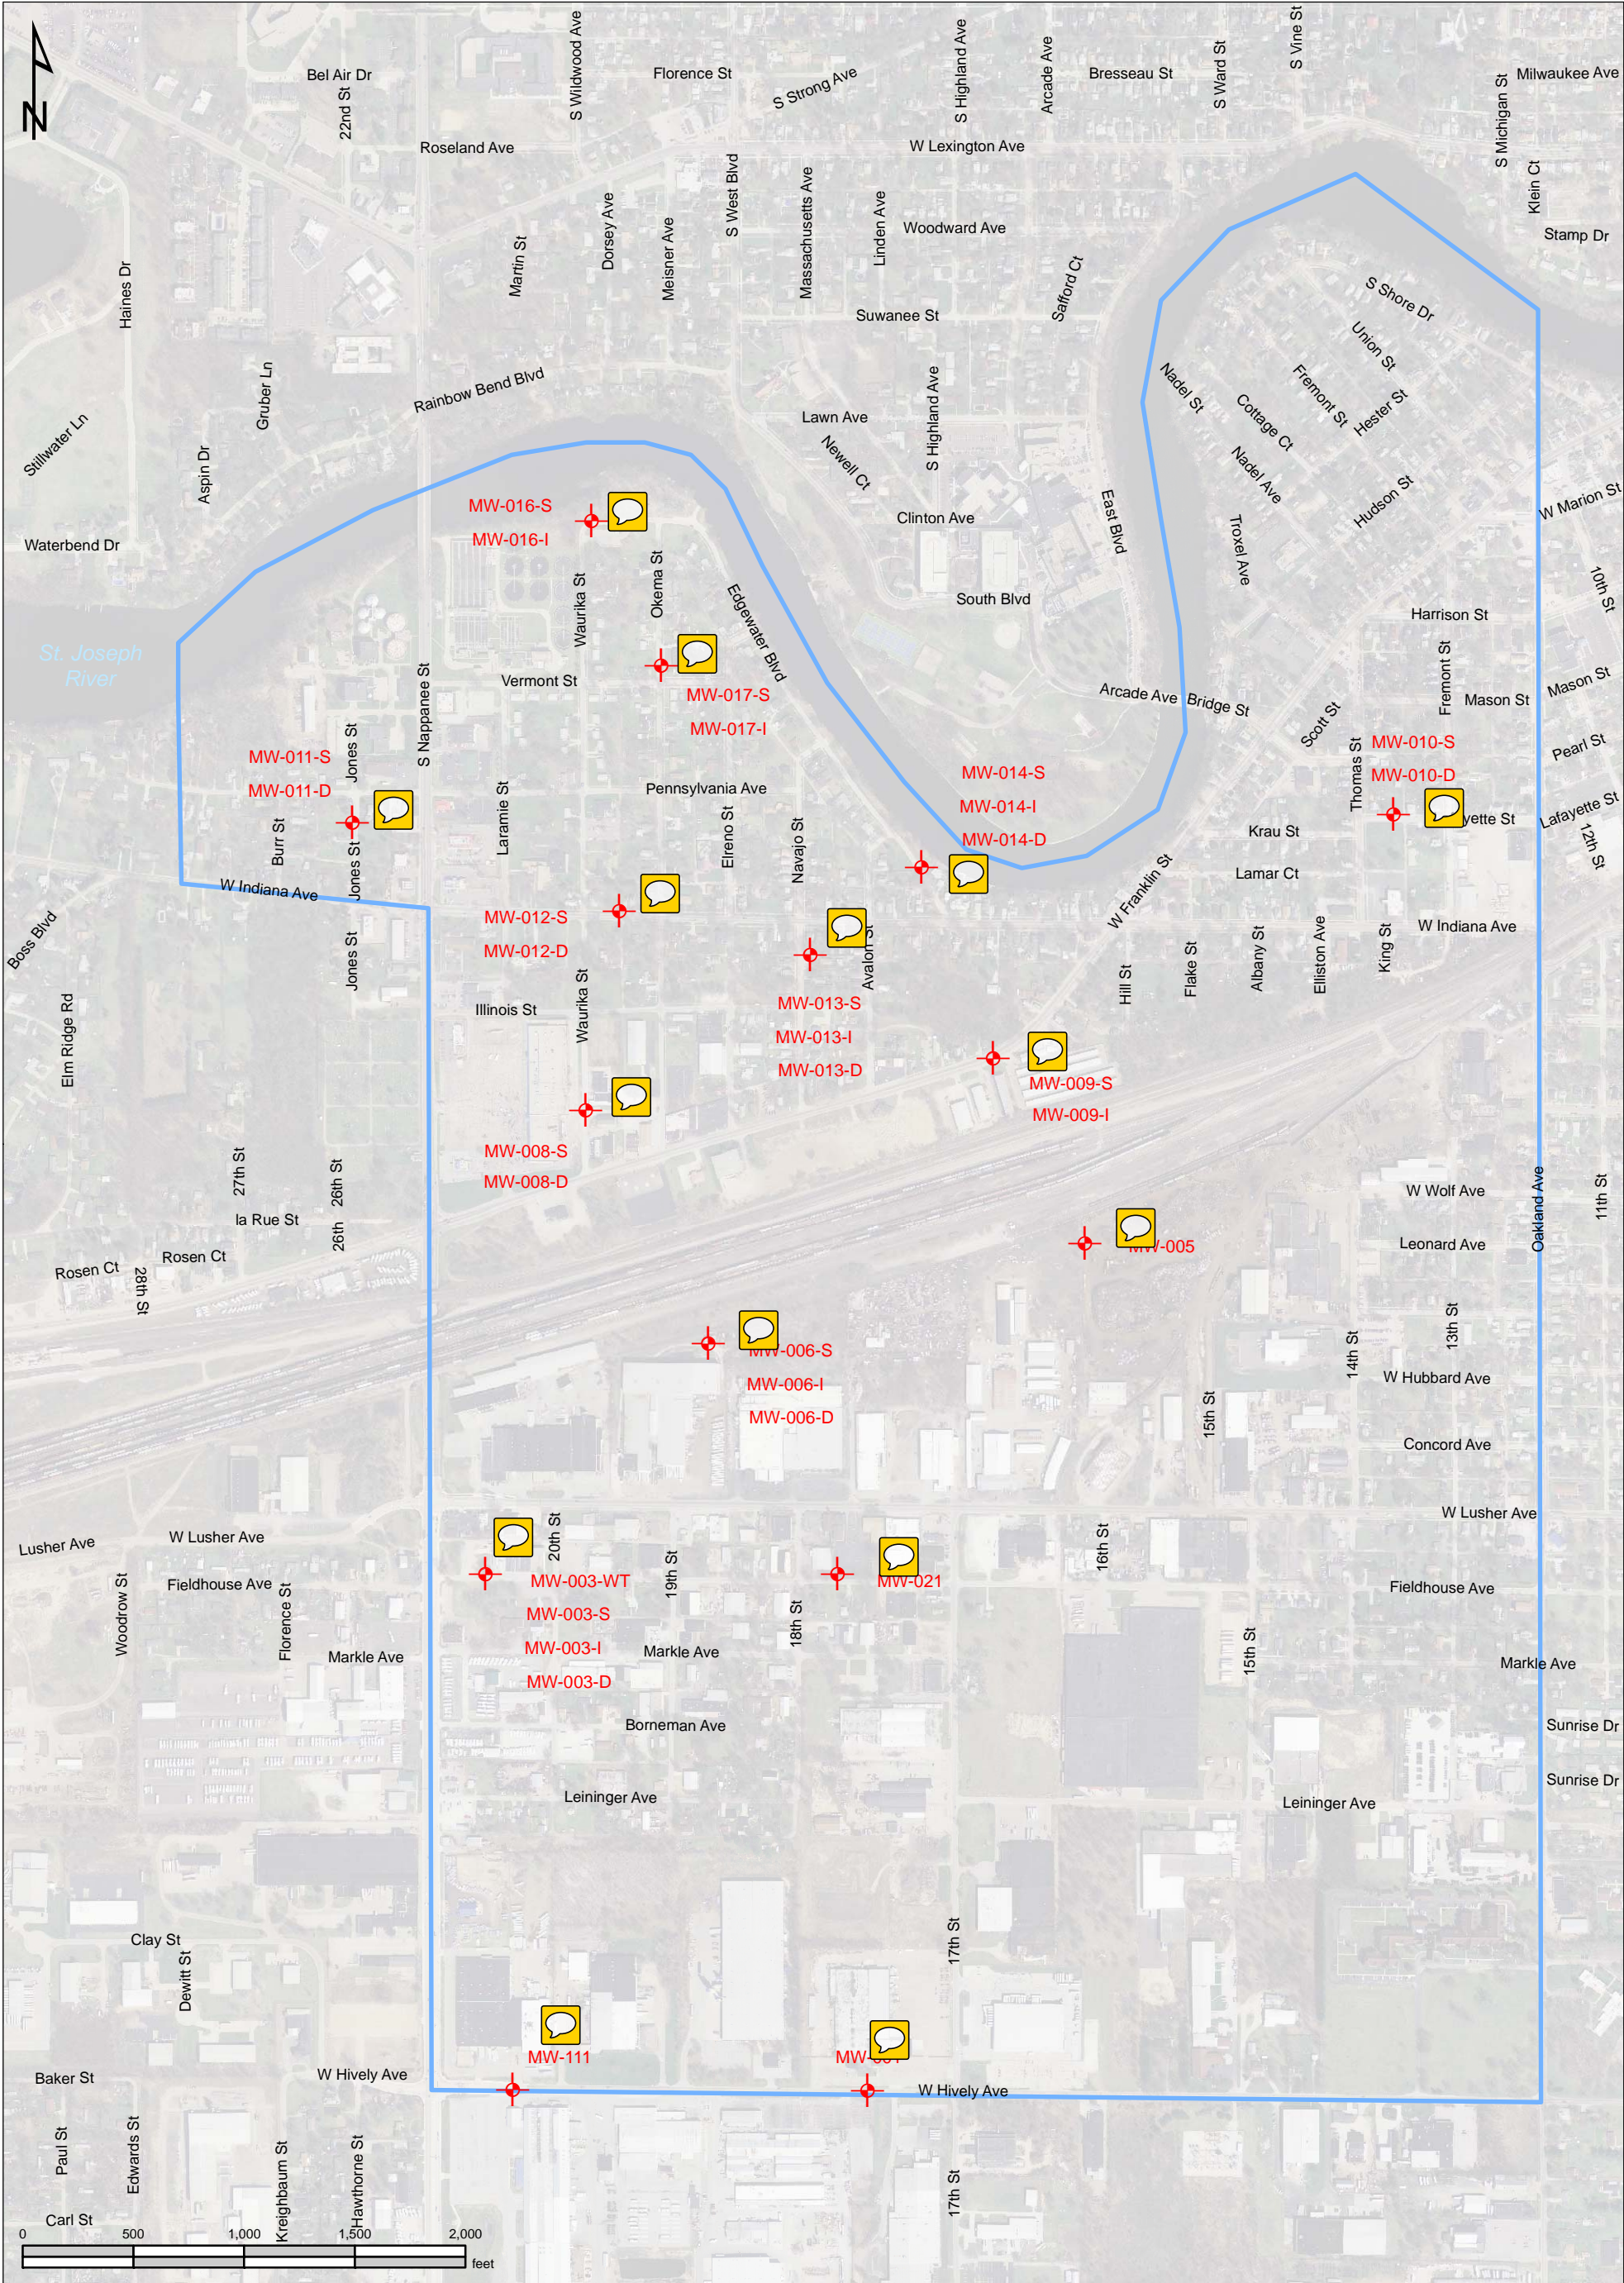
A photo record of the damaged wells is attached. In addition, a figure showing the locations of the wells and their condition is attached.
